Groundwater Recharge at the Kaharoa Rainfall Recharge Site - Rotorua

Prepared by Jonathan Freeman, Environmental Scientist

Groundwater Recharge at the Kaharoa rainfall recorder and lysimeter site, Rotorua

Environmental Publication 2010/21 ISSN: 1175 – 9372 (Print) ISSN: 1179 – 9471 (Online)

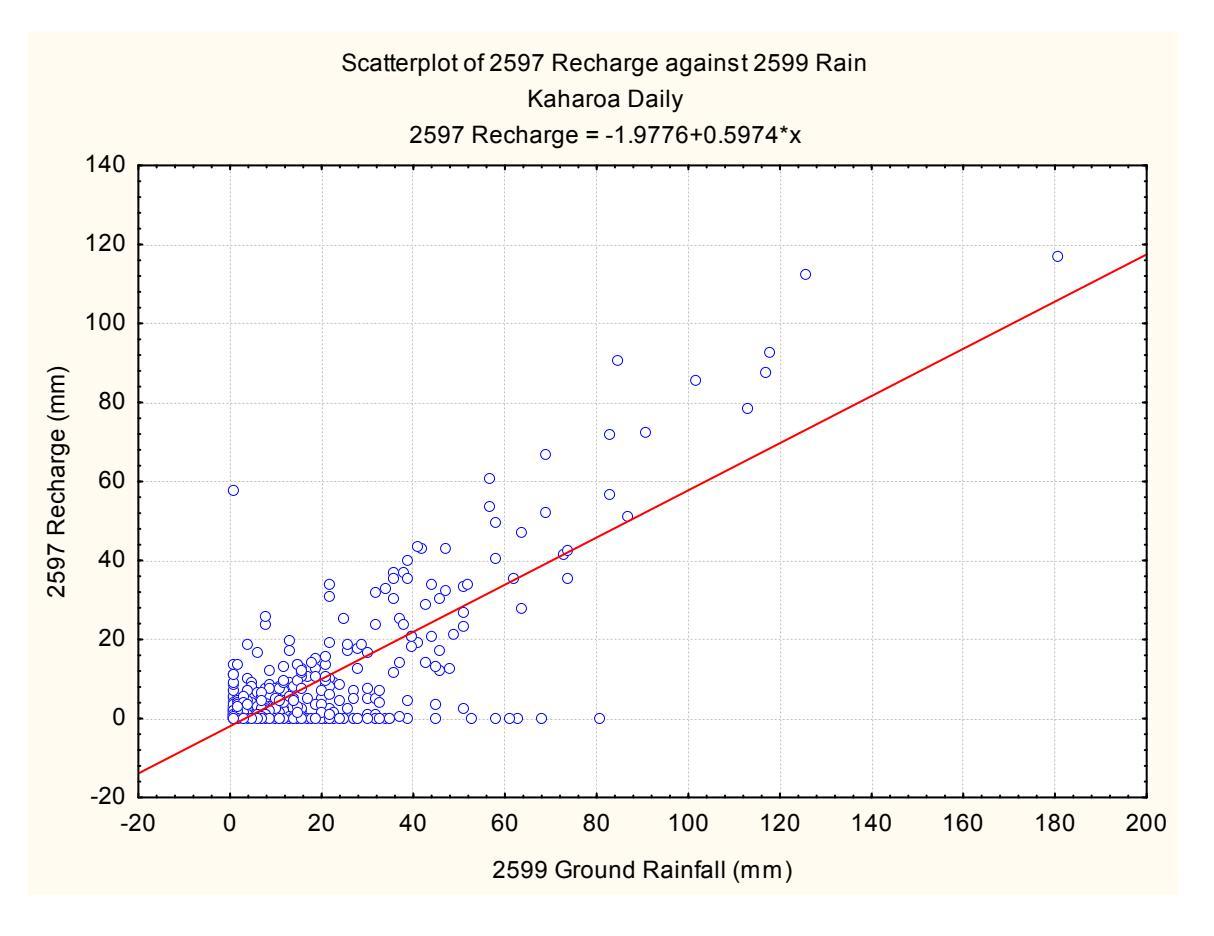
Figure 11 Relationship between ground rainfall and lysimeter 2597. Regression Summary for Dependent Variable: 2597 Recharge (Kaharoa Daily) R= .81938174 R²= .67138644 Adjusted R²= .67090460 F(1,682)=1393.4 p<0.0000 Std. Error of estimate: 7.9702 (Statistical 9.0). Zero data values have not been removed as these are considered significant to the relationship between rainfall and recharge. The inclusion of zero recharge data may result in under prediction at the upper extent of the distribution.

It is apparent from Figure 11 that zero recharge measurements for relatively large events slightly reduce the fit for events at the upper extreme of the record.

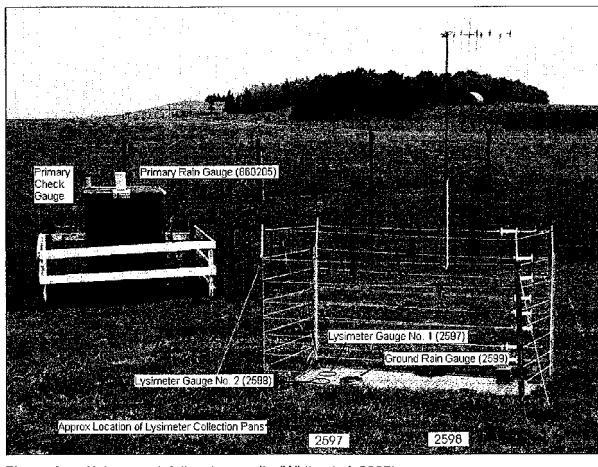
Figure 1 Kaharoa rainfall recharge site (White et al. 2007).

Groundwater recharge from rainfall has been measured at Kaharoa, north of Rotorua, since June 2005 (White et al. 2007) in lysimeters 2597 and 2598 (Figure 1 and Figure 2). Lysimeter 2598 has recorded significantly less rainfall recharge than lysimeter 2597. For example lysimeter 2598 recorded about one third of the rainfall recharge recorded by lysimeter 2597 in the period August 2005 to July 2006 (Table 1).
