**Earthquake Hazards of  
the Bay of Plenty Region  
– Update to 1999**

# Earthquake Hazards of the Bay of Plenty Region - Update to 1999

Institute of Geological & Nuclear Sciences Client Report 1999/116

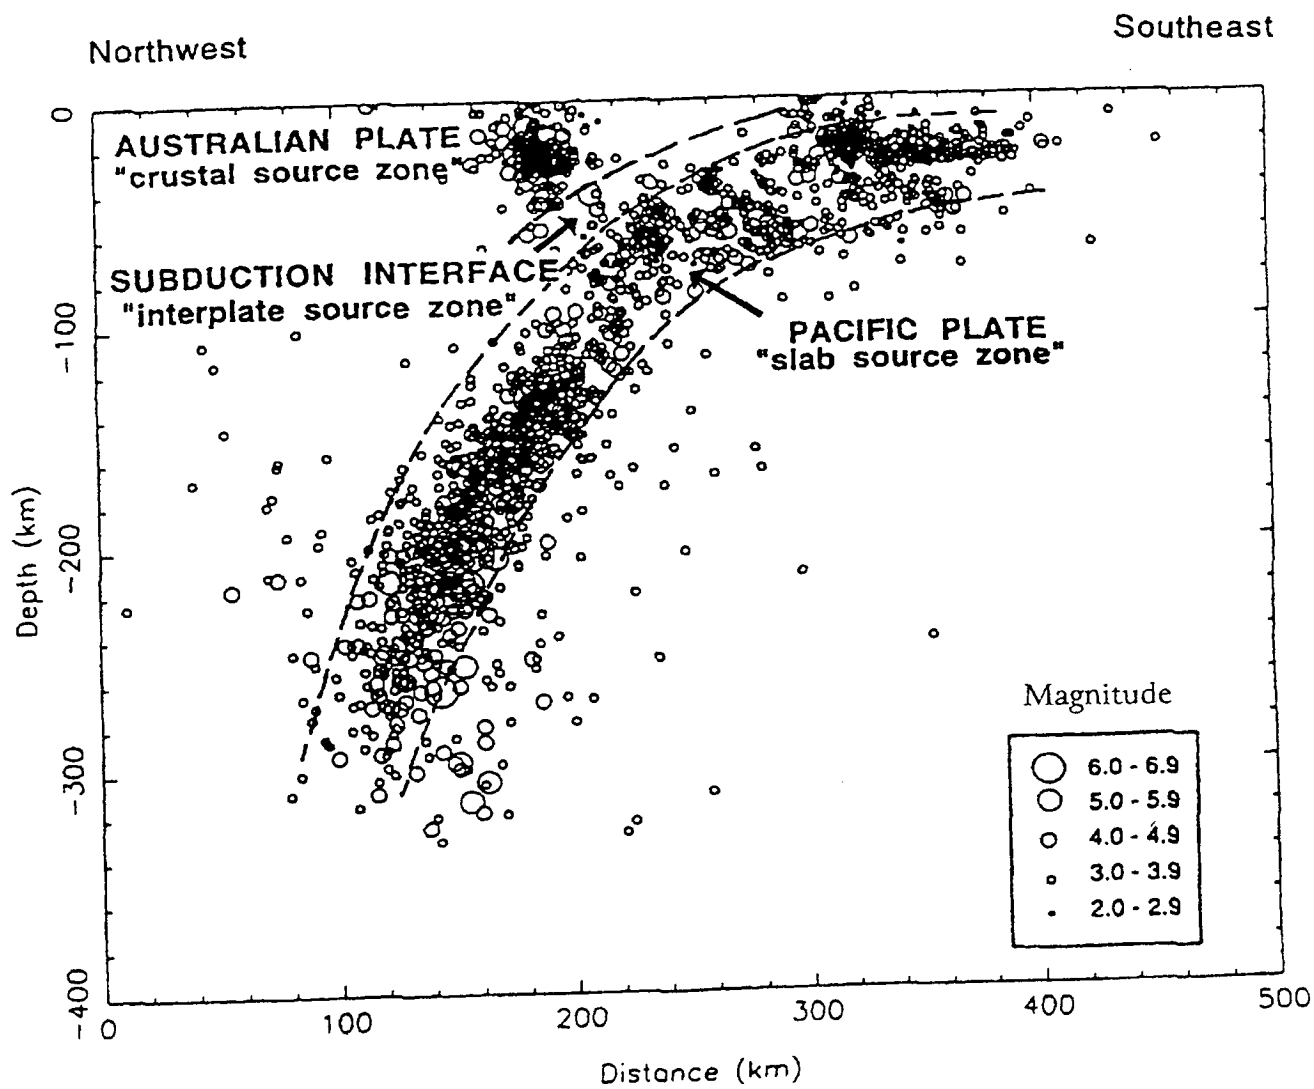
Figure 4 Subduction zone structure in a northwest-southeast section

The Bay of Plenty Region is also underlain by the subducting Pacific tectonic plate (Figures 2 and 4), which is also capable of generating earthquakes. The main source of large earthquakes by this plate tectonics mechanism is caused by sudden slippage in the subduction interface zone, which is the plane of contact between the top of the subducting (underthrusting) Pacific Plate and the Australian Plate. Most of the interface zone, however, may be uncoupled, (Beavan & Haines, 1997) but at those parts at depths of around 18 km in the Raukumara Sector, and 23 km in the Hawkes Bay Sector (Figure 5 and Woodward Clyde/IGNS, 1997), the plates appear to be coupled and potentially the source of very large earthquakes of up to  $M_w$  8.0.

The subducting crustal slab beneath the Bay of Plenty Region is capable of producing earthquakes up to magnitude 8, but very rarely. Smaller earthquakes with sources within the subducting slab are very common (refer Figure 4), but even large ones are not likely to result in damaging intensities of shaking in the Region. This is because of their distance (including the depth dimension), and because the seismic energy travels up the subducting slab, resulting in the strongest shaking being offset to the east of the epicentre. Seismic waves generated by a large earthquake at 100 km depth could be directly beneath Whakatane, but their path is over 200km long, first up the subducting crustal slab, then through over 100km of more highly-attenuating crust of the Australian Plate which includes the exceptionally highly-attenuating Taupo Volcanic Zone westwards from Whakatane.
