The ecological condition of the Rotorua Lakes using LakeSPI - 2010

**NIWA Client Report: HAM2010-047
May 2010**

Environment Bay of Plenty

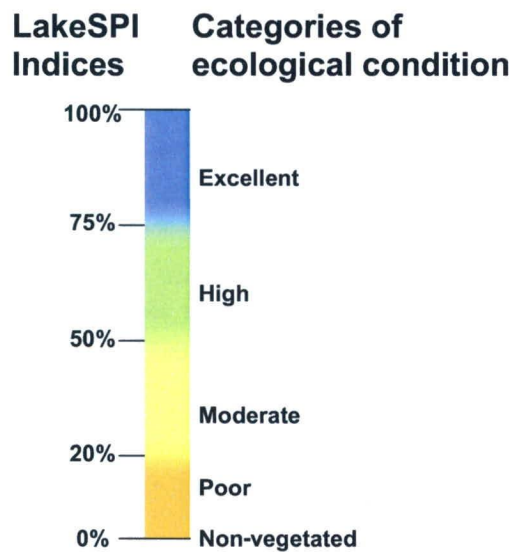
Note: These categories are imposed on a continuum scale of scores; therefore we recognise some flexibility in the placement of lakes with scores close to the transition between categories. Lake placement in these cases will be made using expert opinion based on the current status of the lake and the pressures exerted on it.

Figure 2: LakeSPI indices categorise lakes into five lake condition groups.

For the purposes of ranking and discussing results, lakes have been categorised into five main groups based on the LakeSPI Index. Lakes are grouped as being in an ‘excellent’, ‘high’, ‘moderate’, ‘poor’, or ‘non-vegetated’ condition (Figure 2). These new lake groupings support an MfE initiative to ensure national consistency in terminology and reporting and allow for better comparisons of lakes nationally and regionally.

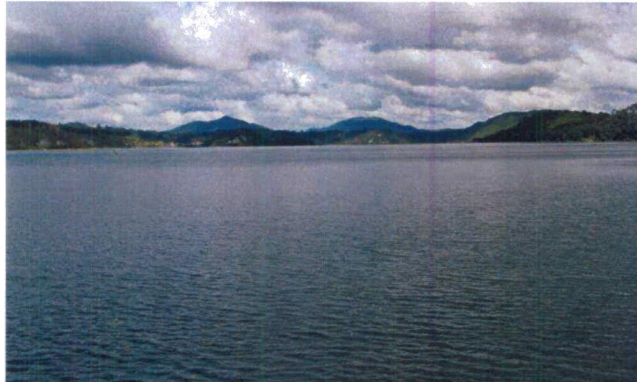
Lake Rotomahana, whilst still the highest ranked lake in the Rotorua region, is declining in condition as indicated by the most recent LakeSPI assessment. This is due to the recent invasion by two of New Zealand's worst aquatic plant species, *Egeria densa* and *Ceratophyllum demersum* (hornwort). Discovered for the first time in April 2007, egeria was found to be established in two areas of the lake, at the north-eastern end and in the southern embayment, while hornwort fragments were found growing amongst native plants in the southern embayment (Clayton & de Winton, 2007; Scholes and Bloxham, 2008). Since then both species have continued to spread, with egeria now present at 3 of the 5 LakeSPI baseline sites (1 site more than 2008) and forming bands of weed growth down to a depth of 9.7 m. The maximum depth of aquatic plant growth at these 3 sites is around 11 m. As both egeria and hornwort continue to have an impact on the diversity and quality of indigenous plant communities in Lake Rotomahana we can expect to see the Native Condition Index decline while the 'Invasive Impact Index' will continue to increase.

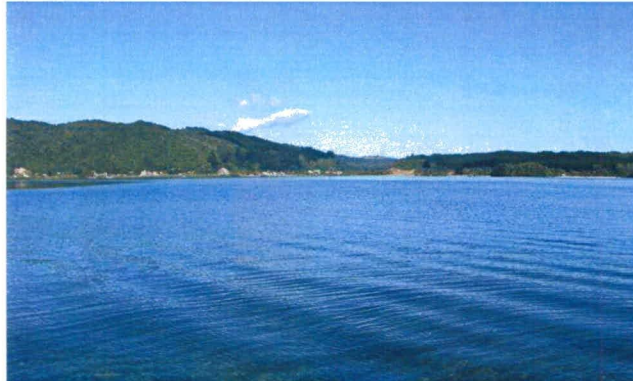
In 1973 Lake Rotoma had a high LakeSPI score, which reflected the early stage of lagarosiphon invasion and the extensive high cover charophyte meadows in this lake. By 1988 the Invasive Impact Index had more than doubled, which in turn reduced both the Native Condition Index and LakeSPI score for this lake. The following 21 years from 1988 to 2009 have shown a more gradual increase in the Invasive Impact Index, but with smaller changes to the Native Condition Index or LakeSPI score. This lake presently has the second highest Native Condition Index after Lake Rotomahana and one of the lowest Invasive Impact Index scores for any of the lakes, which contributes to its high LakeSPI ranking.

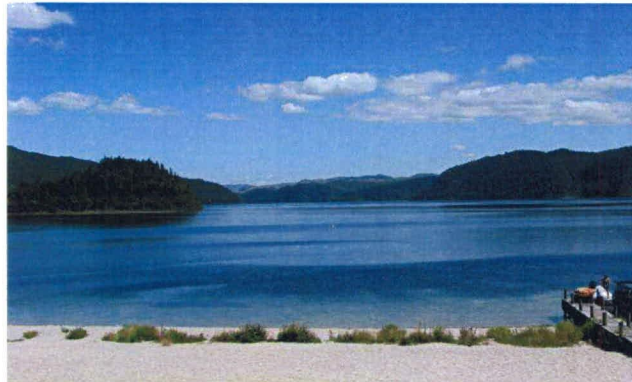
The discovery of an established bed of hornwort (*Ceratophyllum demersum*) during the most recent 2010 survey poses a serious threat to the future condition of Okataina. Hornwort fragments were found at the south-west end of the lake, with a search of the surrounding area revealing an established hornwort weed bed (Figure 3) growing in the middle bay west of Motuwhetero Island (authors pers obs.). Because only a couple of hornwort shoots were recorded from one of the five LakeSPI baseline sites, the Invasive Impact Index and the other indices have not yet been greatly affected.

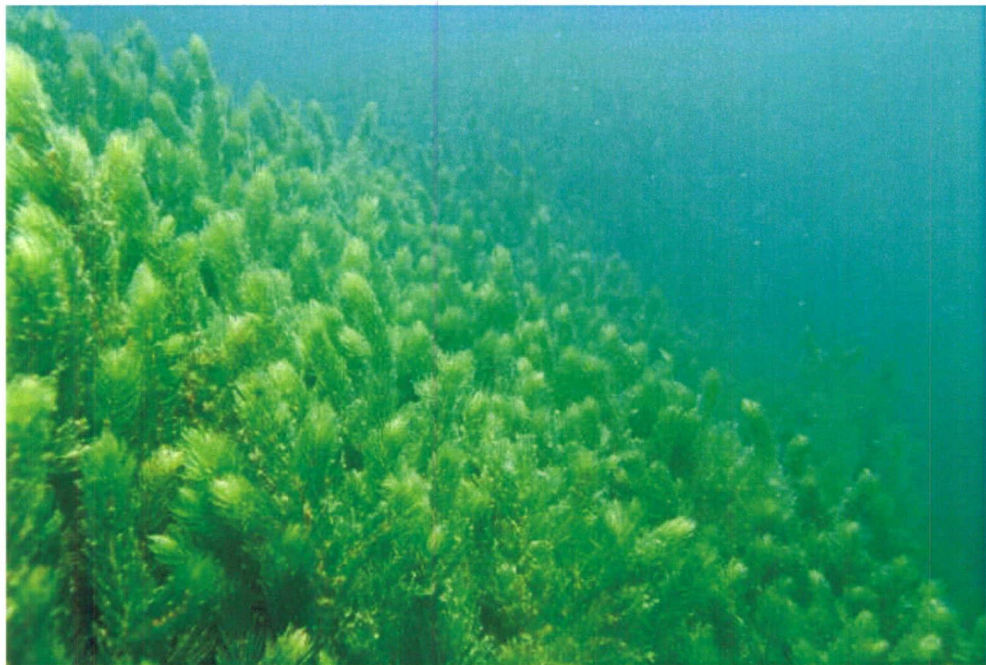
Figure 3: Invasive weed bed of hornwort (*Ceratophyllum demersum*) forming a wall of growth 8 m high and growing down to 12 m depth at the south-western end of Lake Okataina. (Photograph by Rohan Wells)

With the recent discovery of an established weed bed of hornwort growing at the southern end of Lake Okataina, an action plan for this lake has been initiated by EBoP. It is recommended that hornwort be contained and controlled within the cordon area. However, any attempt to eradicate hornwort from within this area should be considered in the context of whether escaped hornwort fragments have established elsewhere.

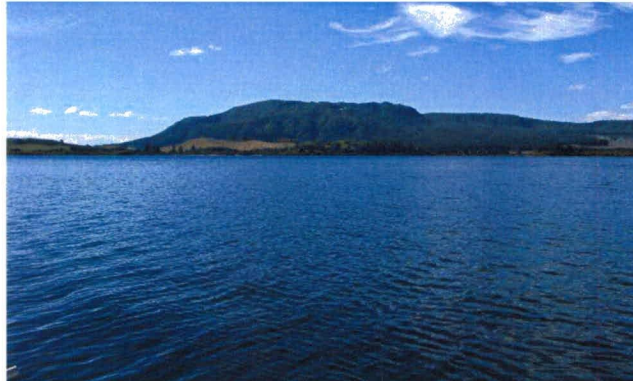
After remaining relatively stable from 1988 to 2008, the most recent LakeSPI assessment shows a decline in the overall condition of Lake Rerewhakaaitu. Increased Invasive Impact scores reflect the wider impacts that egeria is now having upon the lake; and apparent decreases in water quality (author pers obs.) and retraction in charophyte depth limits are concerning for the future state of this lake.

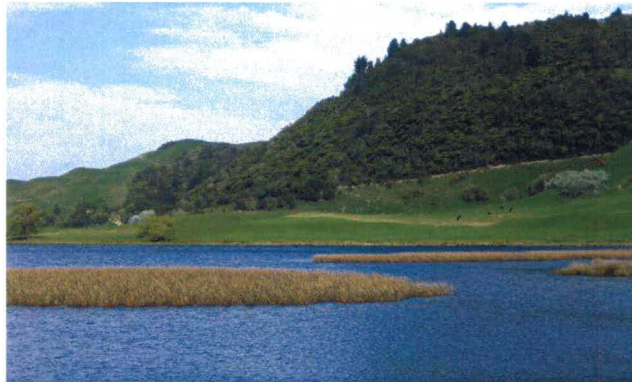
Lake Okareka currently appears to be in a stable condition indicated by the recent LakeSPI indices showing little change over the last six years, from 2003 to 2009. Prior to this however, a 10% decrease in the LakeSPI Index between 1988 and 2003, resulted from a decline in the quality of native plant communities present, indicated by the Native Condition Index, and an increase in the Invasive Impact Index over the same time frame.

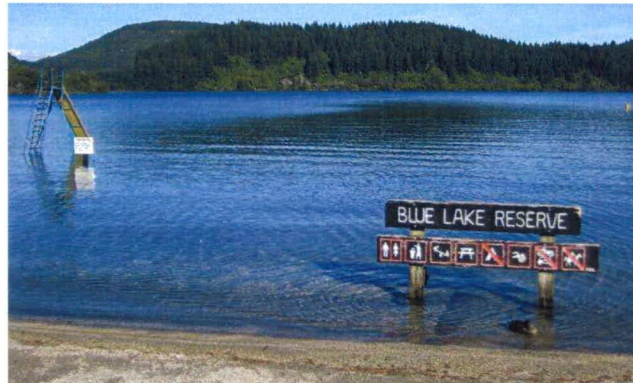
The LakeSPI Index shows a reduction of 29% over the last 22 years to 2010 indicating that the condition of Lake Tikitapu has deteriorated faster than the other 11 Rotorua Lakes over this same period. Unlike the other lakes this decline is not due to the impact from new invasive species but from a substantial decline in the quality and extent of the native plant communities present.

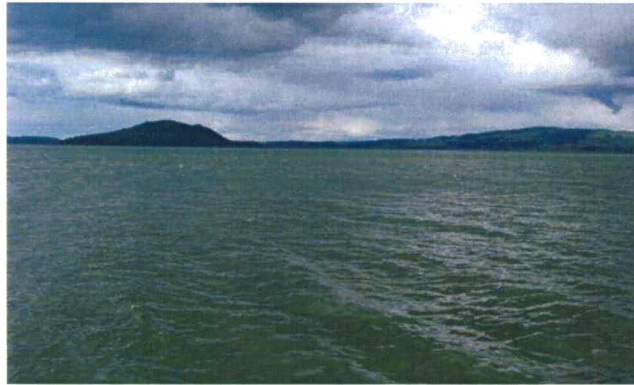
Lake Rotorua is the only lake to have shown improving lake condition scores over the last 21 years. This lake has a large shallow littoral zone subject to considerable wave action, which has the effect of reducing silt build up and helps prevent large surface-reaching weed beds forming around much of the lake margin. The wave washed shallow regions of this lake can support a wide range of native turf-forming species along with shallow water charophyte beds and the presence of these native plants resulted in the higher Native Condition Index generated from the most recent 2009 survey. Charophyte meadows were recorded at 4 of the 5 LakeSPI baseline sites, compared to only 1 site in 2006, and they grew down to a maximum depth of 6.5 m. This and the extended area that the native plant communities are currently occupying has seen a 10% increase in the Native Condition Index for Lake Rotorua over the last 3 years. Care must be taken when interpreting these results however as these shallow water plant communities are also subject to seasonal storms and can be temporary in nature.

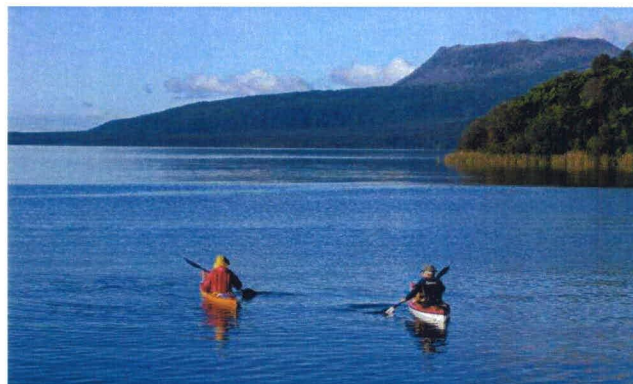
Lake Tarawera remains in a moderate condition and is not expected to change in the near future since the full impact of hornwort (*Ceratophyllum demersum*) has now taken place.

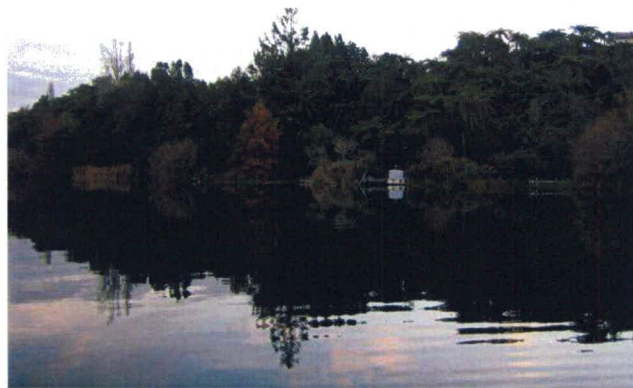
Lake Rotoiti has consistently had one of the highest Invasive Impact Index scores and continued to have one of the lowest LakeSPI Indices so far recorded for any of the 12 lakes in this region. A small increase in the LakeSPI Index over the last 3 years, 2006 to 2009, is attributable to the development of native charophyte meadows at 2 of the 5 LakeSPI baseline sites, growing to a maximum depth of 7.6 m, and is reflected by an increase in Native Condition scores.

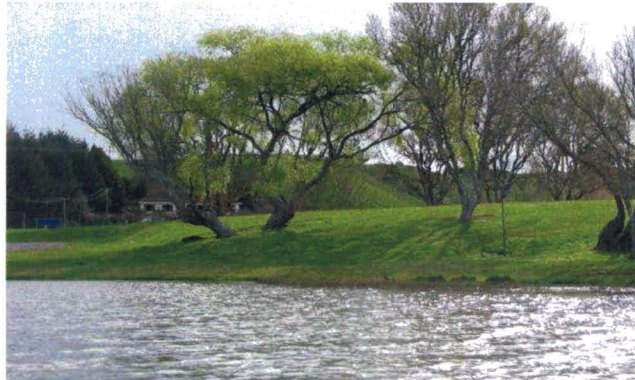
Elodea is the only invasive species currently reported in this lake. The hypereutrophic nature of this lake presents an unfavourable habitat for submerged vegetation. This is reflected in the highly variable cover and depth range of elodea, both seasonally and annually. It is also likely to explain root lyses (root death and detachment) in elodea beds from periods of oxygen stress and anoxia. On several occasions we have observed rooted shallow water elodea beds, while at around 2 m depth and deeper all of the elodea appears as non-rooted ‘drift’. This may well coincide with periods of shallow stratification with severe anoxia below the thermocline resulting in root death and shoot detachment.

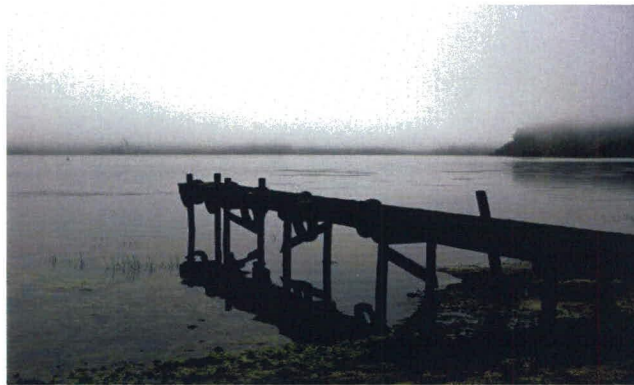
Lake condition: Poor
 Stability: Declining
 Lake ranking: 12th

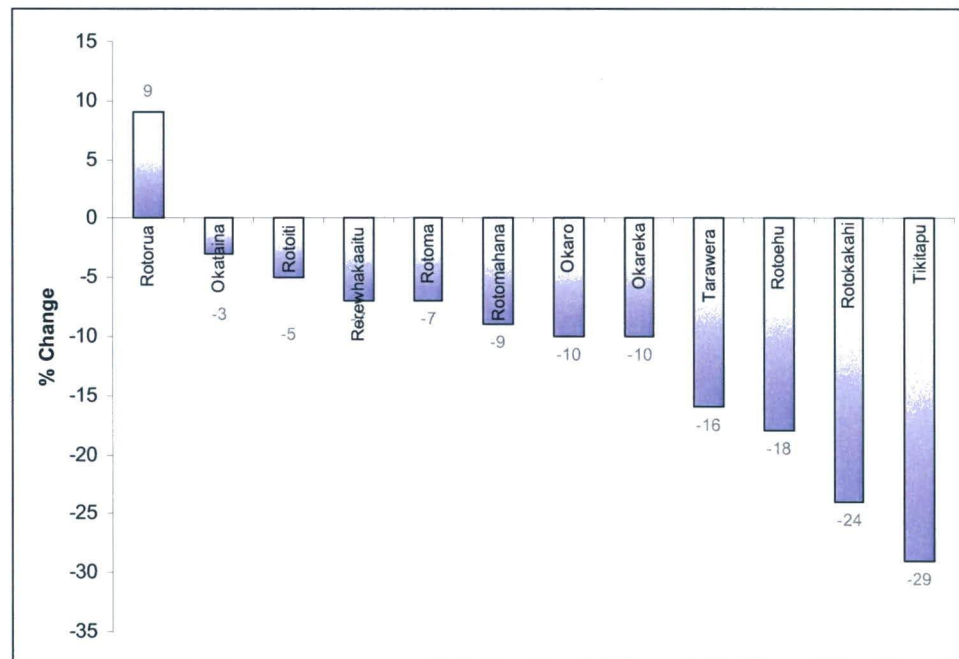
Figure 4: Percentage of change as indicated by the LakeSPI Index over the last 22 years, 1988 to 2009/10.

Many of the Rotorua Lakes have undergone significant change over the last two decades (Figure 4) and continue to be vulnerable to further changes from invasive plants and water quality deterioration. The submerged plant indicators used in LakeSPI provide an effective and alternative means to being able to assess these changes and monitor trends over time.

Lakes Tikitapu and Rotokakahi show the biggest change in lake condition over the last 20 years resulting from a notable reduction in the quality and extent of native submerged vegetation present in the lakes. There has been no new invasive species in either lake since full lake surveys in 1988, so these changes are likely the result of deteriorating water quality and clarity. Submerged plants are able to integrate long term changes in water clarity and nutrient status over time and often one of the first signs of deterioration is a retraction of the lower depth limit of plant growth (Schwarz et al. 1999). In many lakes the first valuable plant community to disappear is the charophyte meadow that grows into deeper water and this has been the case in Lake Tikitapu. In 1988 Lake Tikitapu supported extensive charophyte meadows at all 5 LakeSPI sites down to a mean depth of 19.5 m. By 2008, charophyte meadows ($\geq 75\%$ cover) were found at only one LakeSPI site with remnants ($\leq 5\%$ cover) found at one

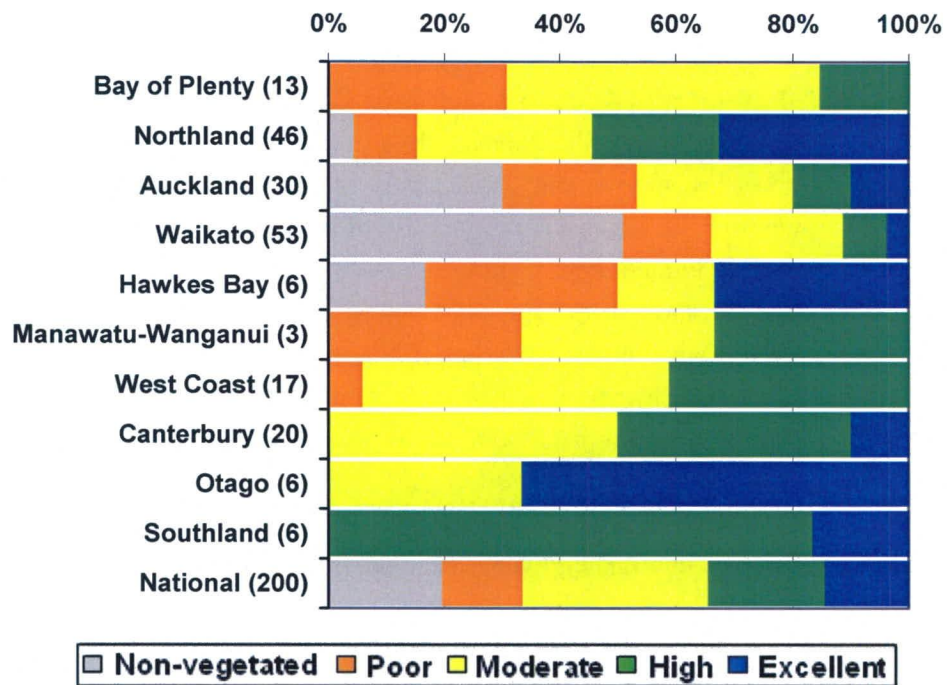
Figure 5: Proportions of lakes designated by the LakeSPI classification system showing regional and national differences, with number of lakes shown in parenthesis. Note some regions have had only limited LakeSPI assessments carried out and are therefore under-represented in terms of lake surveys.

A 'moderate' condition category contains the majority of the Rotorua Lakes and contains the largest proportion of lakes nationally. This 'moderate' condition group of lakes are representative of those lakes that are impacted in varying degrees by invasive weeds.

A smaller proportion of the Rotorua Lakes are classified as being in a 'poor' condition. This group of lakes tends to represent those with extensive invasion and dominance by one of the country's worst weeds, hornwort (*Ceratophyllum demersum*), as is the case for 2 of the 3 Rotorua Lakes ranked in this 'poor' category. Similar groups of substantially invaded lakes are represented in the Waikato, Auckland, and the Hawkes Bay Regions in particular. Water quality issues that have created unfavourable conditions for submerged plant growth are also often represented in this group of 'poor' condition lakes (e.g., Lake Okaro).
