Tauranga Moana
State of the Environment Report 2019
Environmental Publication 2019/04

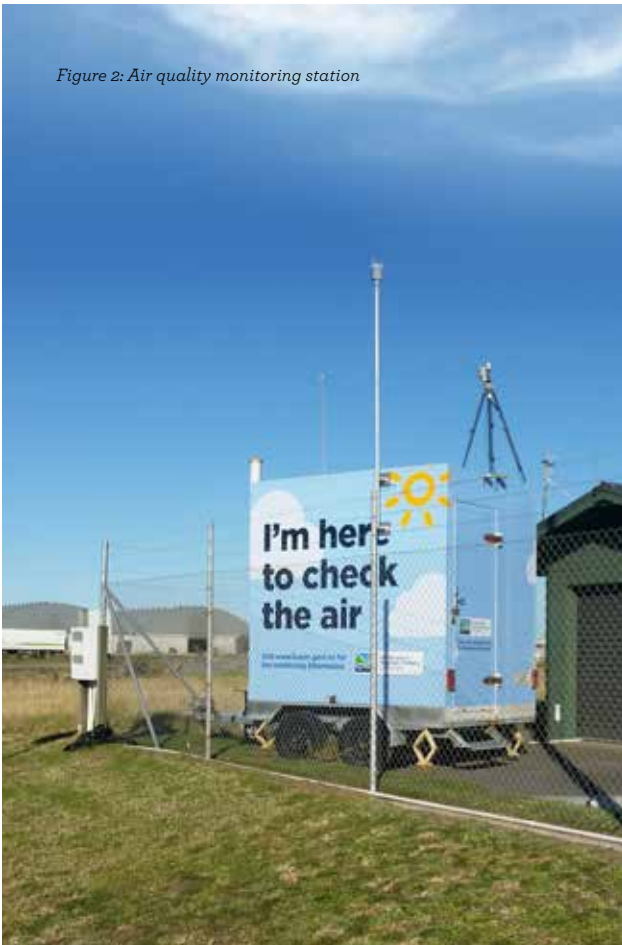
Figure 2: Air quality monitoring station

Concentrations of PM₁₀ are continuously recorded at one key site in Otumoetai. Air quality monitoring instruments are housed inside a specially designed monitoring station where temperature and humidity are controlled (Figure 2). Outdoor air is drawn inside the housing where it is sampled and analysed by the monitoring instruments. The data is then transmitted automatically to a database at BOPRC. Here we report on data collected in 2016 as part of our Air Quality monitoring programme.

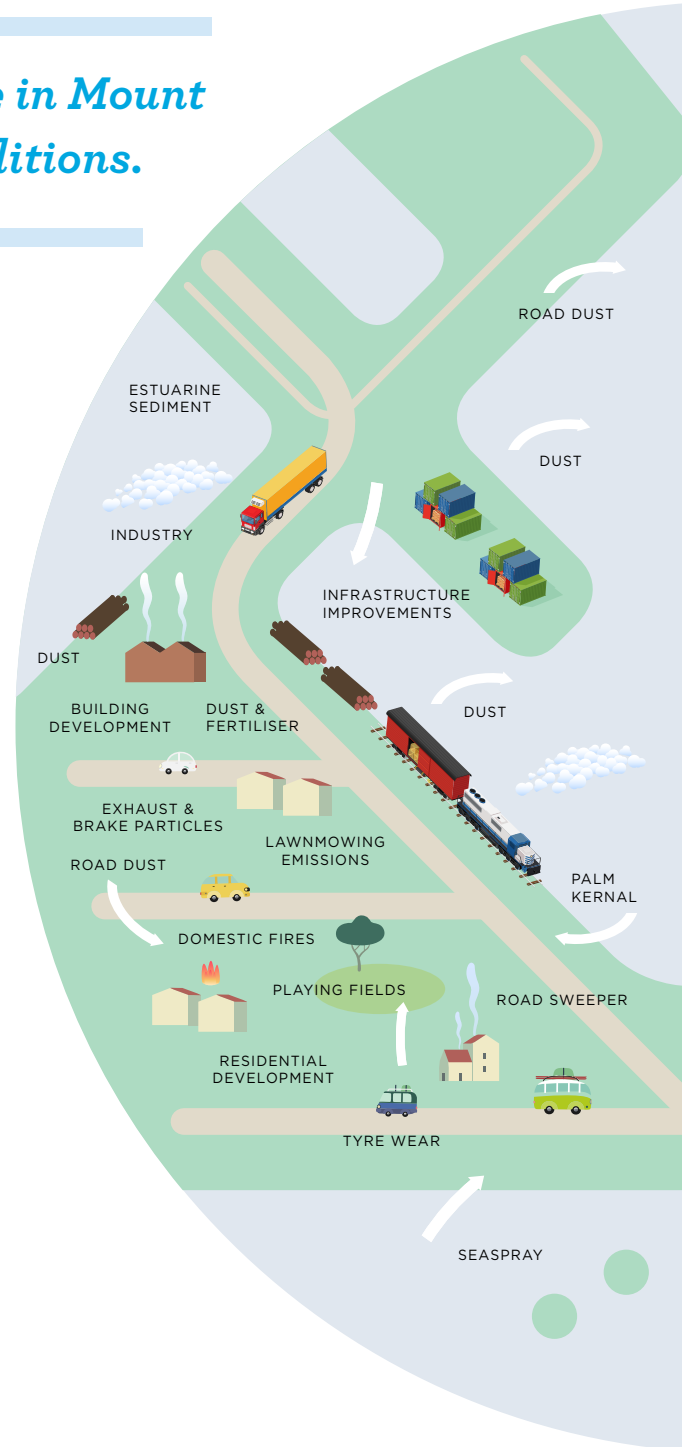
Figure 1: Sources of nuisance dust in Mount Maunganui.

Nuisance dust includes industrial particles created by activities at the Port of Tauranga, wind-blown sand and soil, transportation emissions, pollen, road dust, grain and stock feeds, palm kernel and tyre wear particles (Figure 1). Large particles of dust in the air, if inhaled, can cause a range of nuisance effects, such as irritated eyes and respiratory issues. They can also cause a visual nuisance when they deposit and build up on clean surfaces both inside and outside of houses, on garden plants, flowers and vegetables. High levels of nuisance dust can occur in the Mount Maunganui when certain weather conditions exist (for example strong dry westerlies).

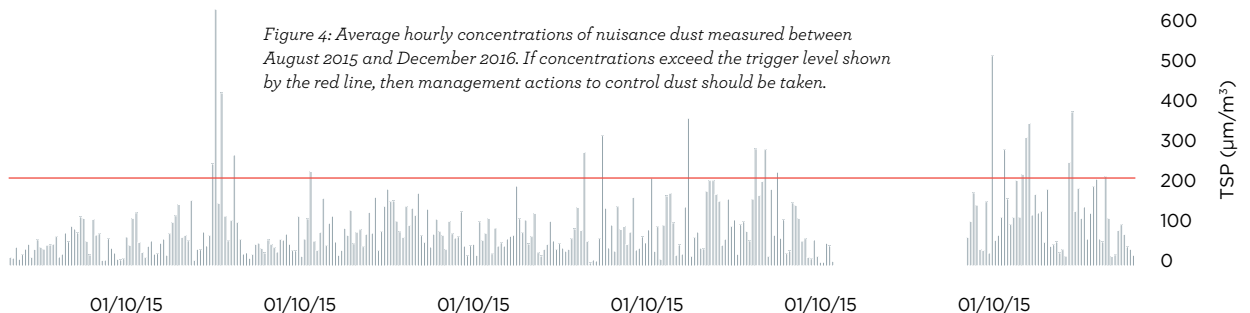
Figure 4: Average hourly concentrations of nuisance dust measured between August 2015 and December 2016. If concentrations exceed the trigger level shown by the red line, then management actions to control dust should be taken.

Continuous monitoring of nuisance dust in Mount Maunganui started in August 2015. Since then, the occurrence of nuisance dust events does not appear to have changed. (Figure 4). However, we expect the occurrence of nuisance dust to decrease in the future as the actions are implemented by Council. A new air monitoring programme at Mount Maunganui and Sulphur Point has been finalised, and six new monitoring stations have been implemented to measure nuisance dust, sulphur dioxide, methyl bromide and weather conditions⁹.

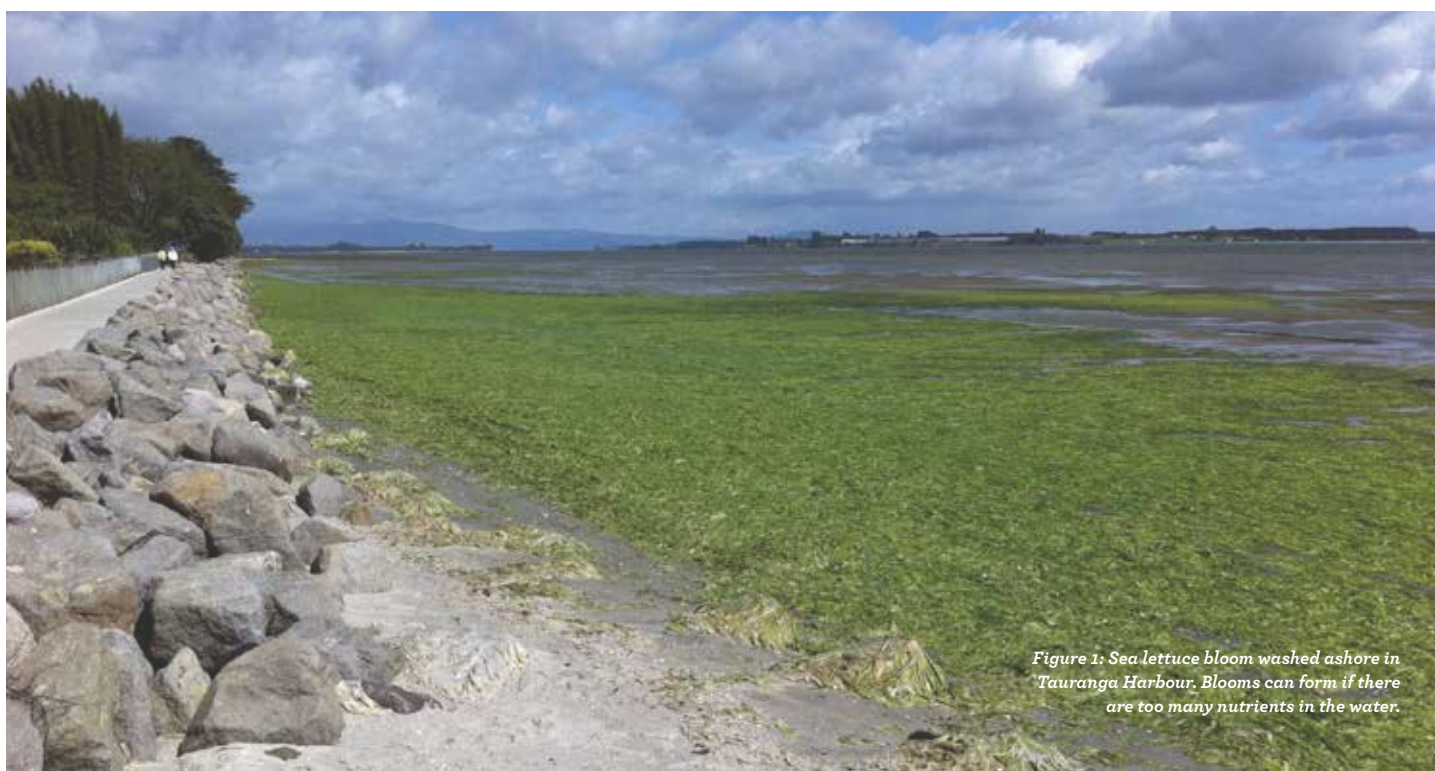
Figure 1: Sea lettuce bloom washed ashore in Tauranga Harbour. Blooms can form if there are too many nutrients in the water.

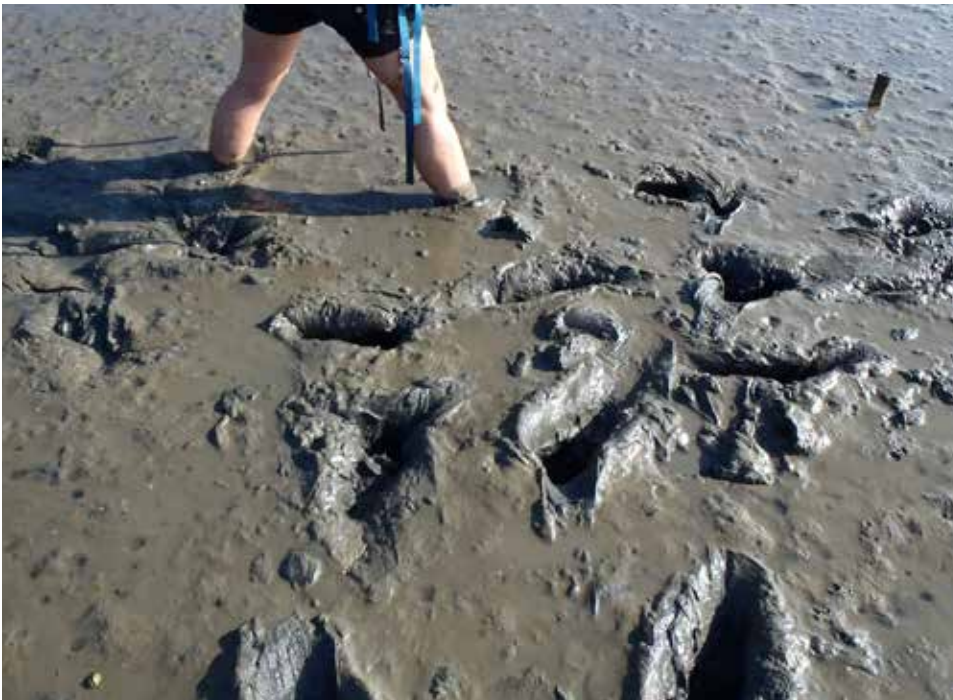
Figure 1: Upper Te Puna estuary. The sediments at this site are very fine and have a high mud content.

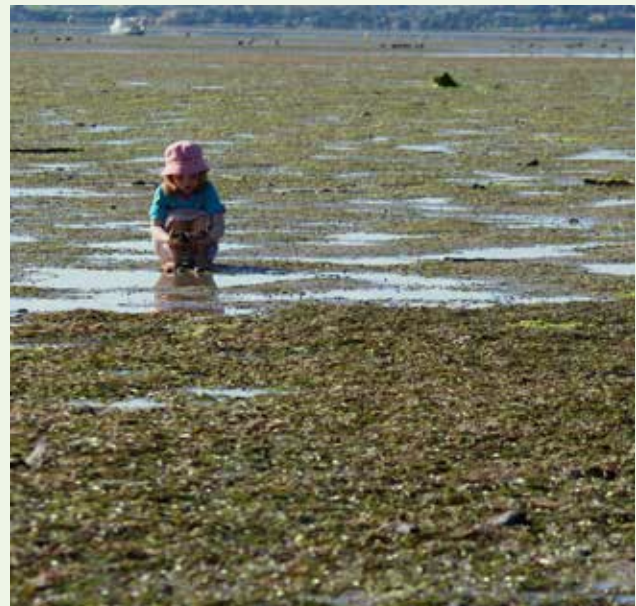
Figure 1: Seagrass beds exposed during low tide at Otumoetai. Large patches caused by swan grazing.
