Tauranga Moana

State of the Environment Report 2019

Environmental Publication 2019/04

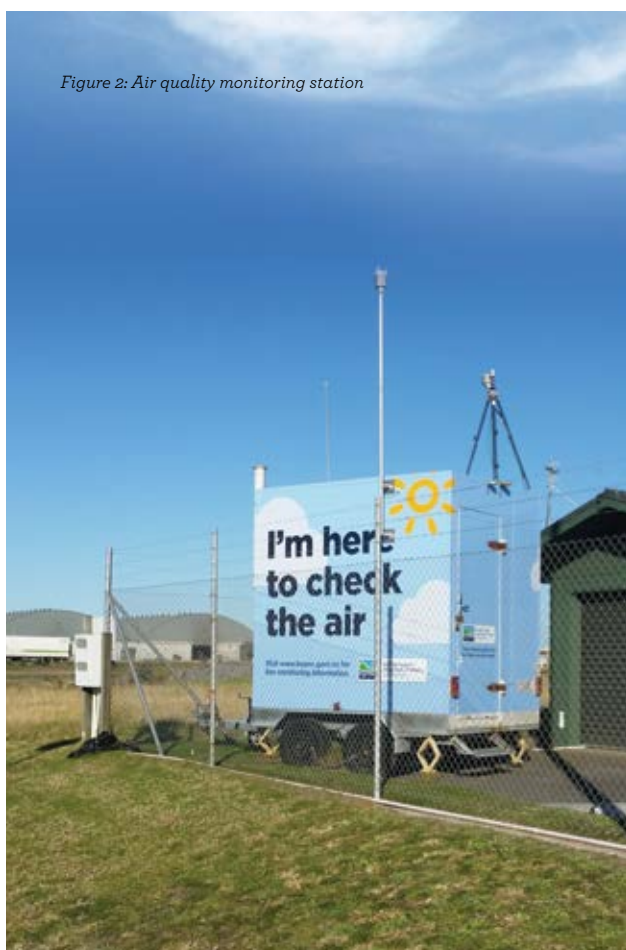
Figure 2: Air quality monitoring station

Concentrations of PM₁₀ have been continuously recorded at one key site in Otumoetai since 1998. Seven new sites were added in late 2018 stationed around the Mount Industrial Area. Air quality monitoring instruments are housed inside a specially designed monitoring station where temperature and humidity are controlled (Figure 2). Outdoor air is drawn inside the housing where it is sampled and analysed by the monitoring instruments. The data is then transmitted automatically to a database at BOPRC. Here we report on data collected up to June 2019 as part of our Air Quality monitoring programme.

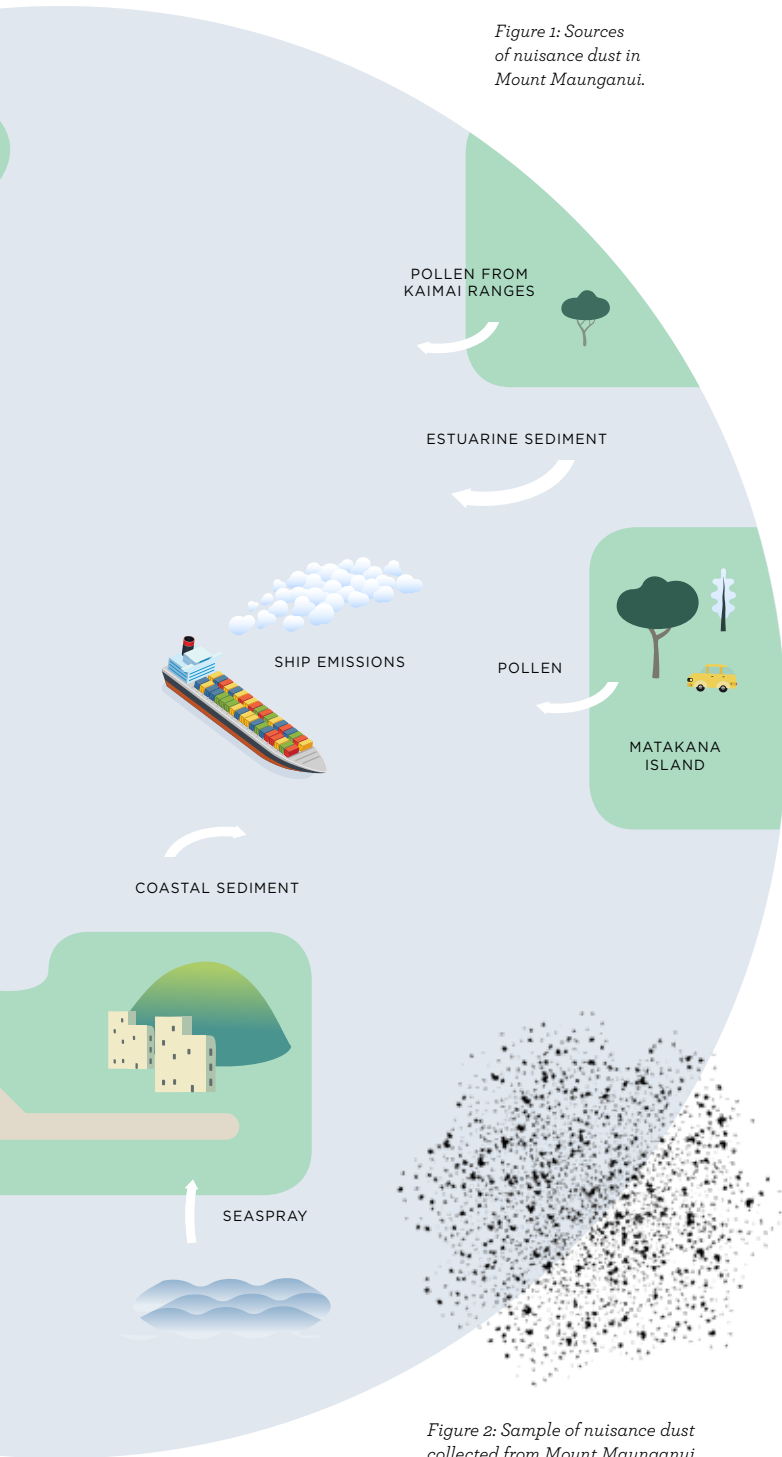
Figure 2: Sample of nuisance dust collected from Mount Maunganui.

The nuisance dust indicator measures the amount of total suspended particulates (TSP) in the air. These are any airborne particles that are smaller than 100 µm in diameter, which is about the same thickness as a sheet of paper (Figure 2).

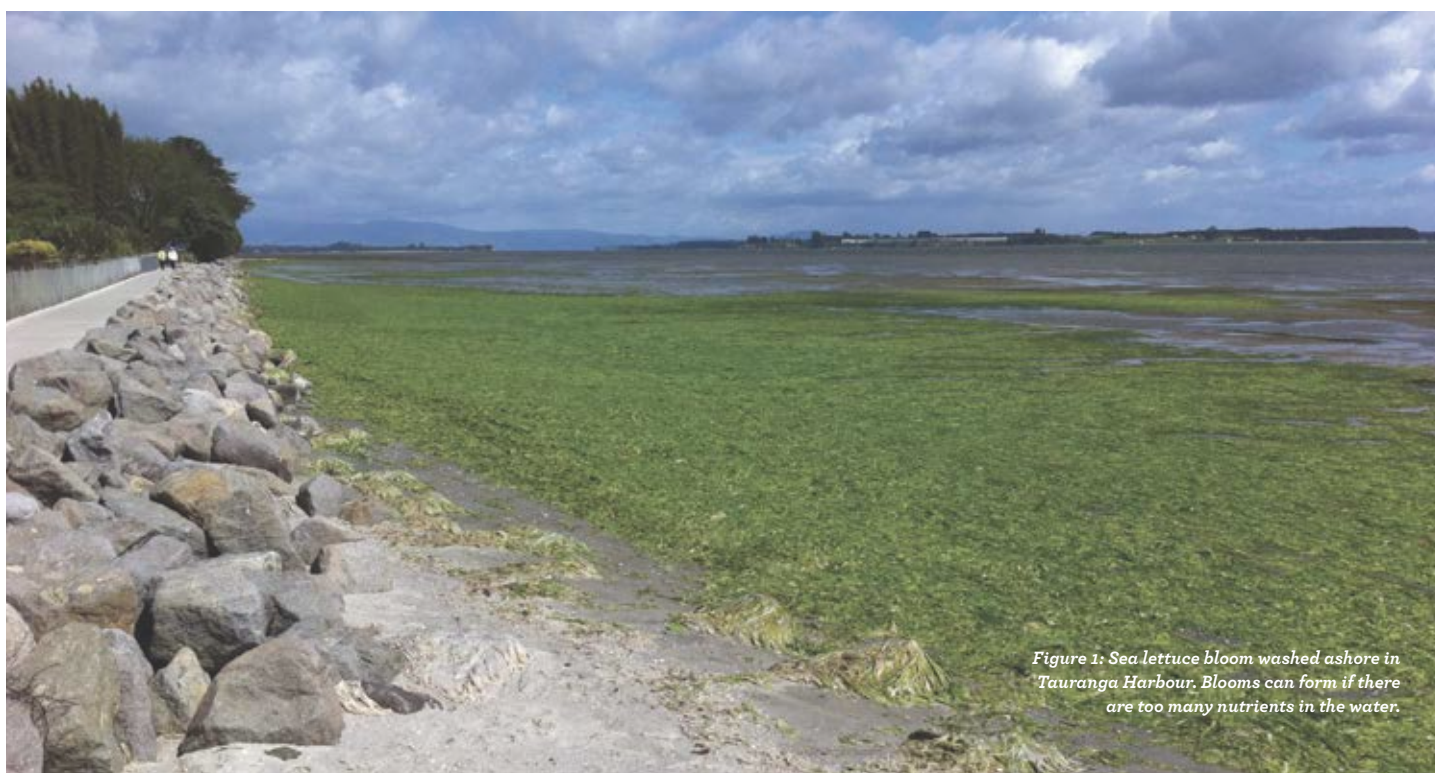
Figure 1: Sea lettuce bloom washed ashore in Tauranga Harbour. Blooms can form if there are too many nutrients in the water.

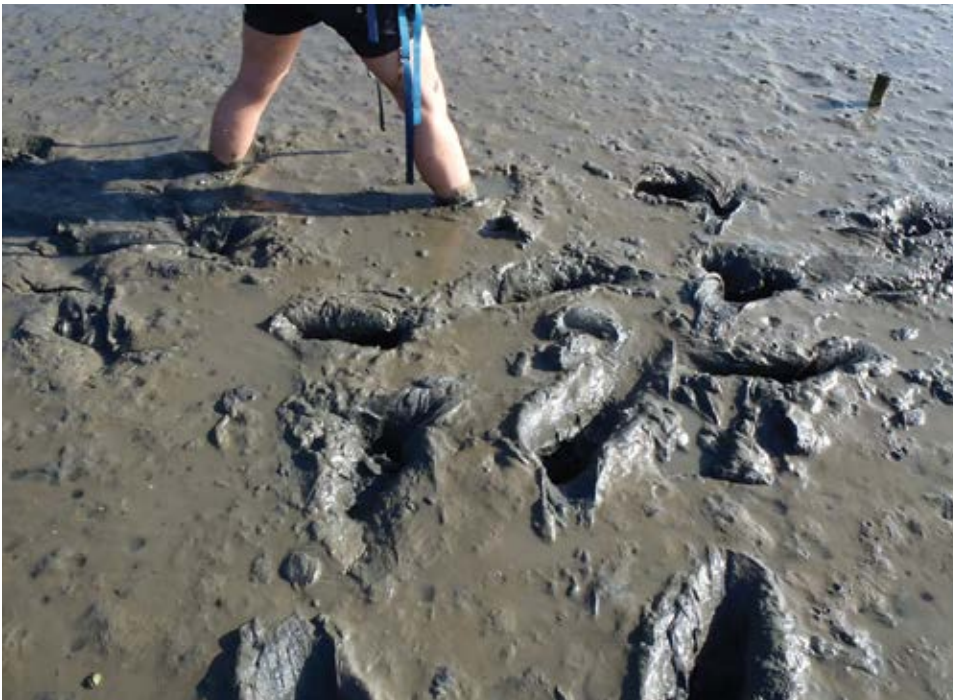
Figure 1: Upper Te Puna estuary. The sediments at this site are very fine and have a high mud content.

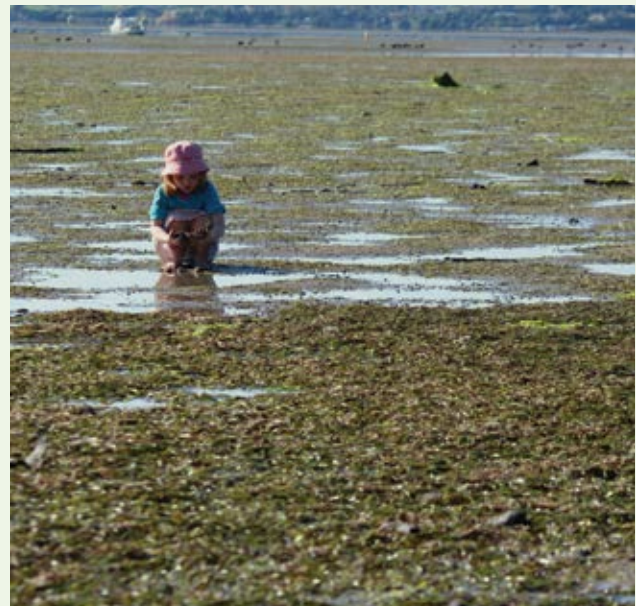
Figure 1: Seagrass beds exposed during low tide at Otumoetai. Large patches caused by swan grazing.

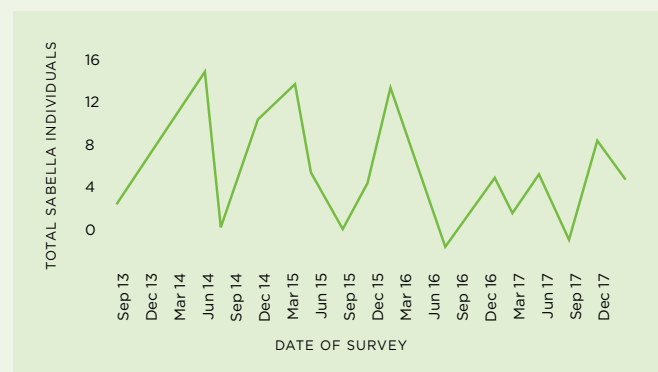
Figure 1. The total number of Mediterranean fanworm (*Sabella spallanzanii*) individuals found across Tauranga Marinas from September 2013.
