The ecological condition of the Rotorua Lakes using LakeSPI - 2009

**NIWA Client Report: HAM2009-162
September 2009**

The ecological condition of the Rotorua Lakes using LakeSPI-2009

Environment Bay of Plenty

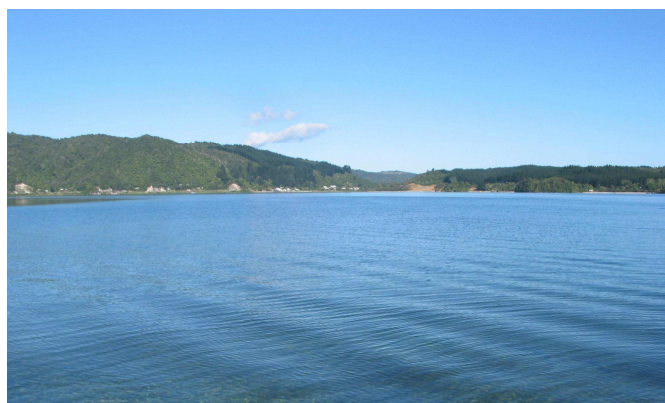
Lake condition: High

Stability: Declining

In 1973 Lake Rotoma had a high LakeSPI score, which reflected the early stage of *Lagarosiphon* invasion and the extensive high cover charophyte meadows in this lake. By 1988 the Invasive Impact Index had more than doubled, which in turn reduced both the Native Condition Index and LakeSPI score for this lake. The following 21 years from 1988 to 2009 have shown a more gradual increase in the Invasive Impact Index, but with minimal change to the Native Condition Index or LakeSPI score. This lake presently has the second highest Native Condition Index after Lake Rotomahana and one of the lowest Invasive Impact Index scores for any of the lakes, which contributes to its high LakeSPI ranking.

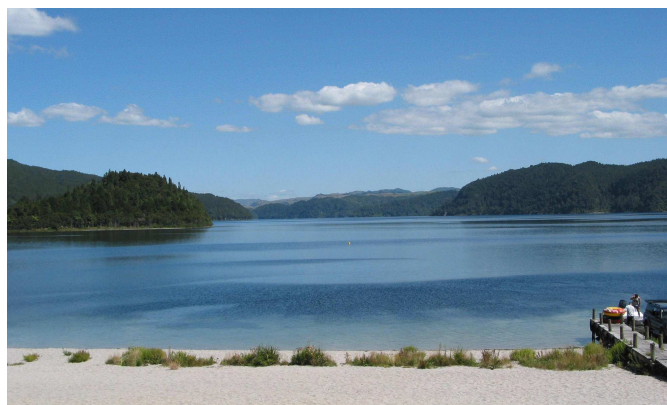
Lake condition: Moderate

Stability: Stable

LakeSPI scores for Lake Okataina have been reasonably stable with only minor fluctuations in LakeSPI condition over the last 28 years from 1981 to 2009. Care must be taken in interpreting these results since Lake Okataina has no outlet, and water levels can vary by several metres. Although lake level changes tend to be quite slow, they can still affect the available habitat for submerged vegetation in shallow water and the corresponding adjustments in the maximum depth of charophyte colonisation may respond more slowly.

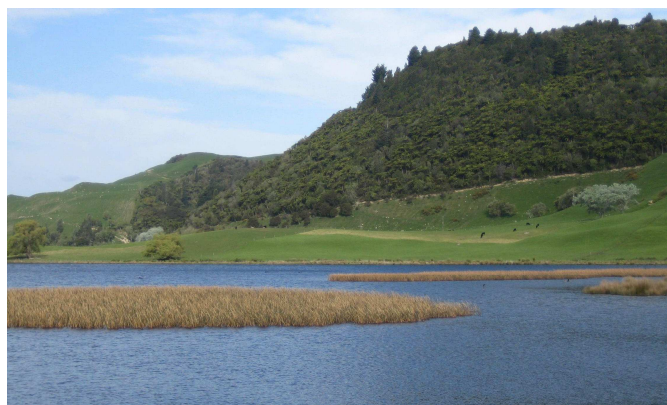
Lake condition: Moderate

Stability: Stable

Lake Okareka currently appears to be in a stable condition indicated by the recent LakeSPI indices showing little change over the last six years, from 2003 to 2009. Prior to this however, Lake Okareka recorded a 10% decrease in the LakeSPI Index between 1988 and 2003, resulting from a decline in the quality of native plant communities present, indicated by the Native Condition Index, and an increase in the Invasive Impact Index over the same time frame.

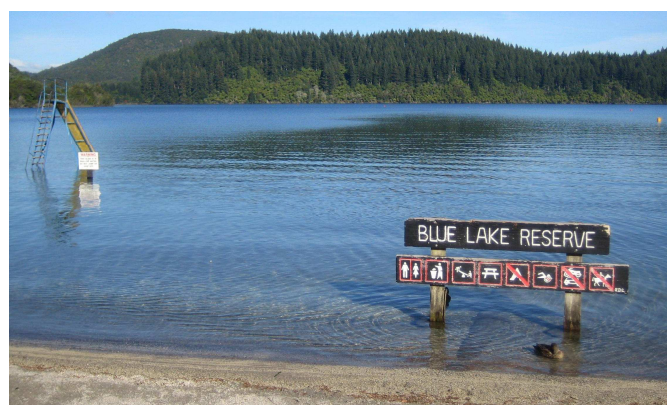
Lake condition: Moderate

Stability: Declining

The LakeSPI Index shows a reduction of 31% over the last 20 years indicating that the condition of Lake Tikitapu has deteriorated faster than any of the other 11 Rotorua Lakes over this same period from 1988 to 2008. Unlike the other lakes this decline is not due to the impact from new invasive species but from a significant decline in the quality and extent of native plant communities present. The mean maximum depth of native plant growth at LakeSPI survey sites has decreased from 12.4 m in 2005 to only 8.8 m in 2008 resulting in a 47% decline in the 'Native Condition Index' over the last 3 years. This notable reduction in native condition is most likely related to water quality, in particular water clarity near the maximum depth limit of vegetation growth. The presence of a sustained turbid water layer with high chlorophyll *a* levels has been reported above the thermocline (David Hamilton, Waikato University, pers comm.). The increase in Invasive Impact scores over this same time frame has occurred not on account of any new invasive plant introductions or spread of existing invasive plants but rather due to the existing invasive vegetation now having a greater relative impact on overall vegetation status.

Investigations should be carried out into the causes of water quality and clarity degradation in Lake Tikitapu and Rotokakahi.

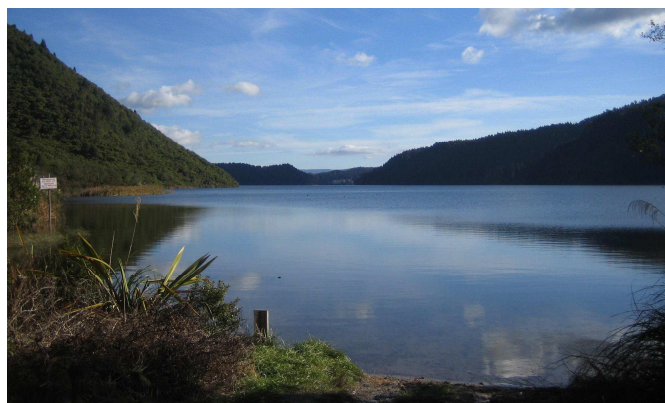
Lake condition: Moderate
 Stability: Declining
 Lake ranking 7th

Lake Rotokakahi has undergone the second largest decline behind Lake Tikitapu shown for any of the 12 lakes over the same 20 year time period. The LakeSPI Index has decreased by 21% from 1988 to 2008, whilst the Native Condition Index has almost halved with a 29% reduction largely due to a decline in charophyte meadows. This has occurred even though there has been no change in the dominant invasive species (*Elodea canadensis*) in this lake; although the relative impact of invasive presence on overall submerged vegetation has increased. The declining condition of Lake Rotokakahi, like Lake Tikitapu, is not due to invasive weeds but rather a decline in native condition presumably due to a reduction in water quality. Additional observations support this in Lake Rotokakahi, with filamentous algae prevalent on submerged vegetation and blue-green algal mats often covering sediments beyond the maximum depth of plant growth. These are indicators of poor lake health. Nutrient inputs are likely to be entering this lake from the predominantly farmland catchment as well as from sediment nutrient release during summer stratification. Recent logging in the catchment appears to have further increased lake turbidity since the last 2008 LakeSPI survey. A decline in oxygen content in deeper water has been noted by David

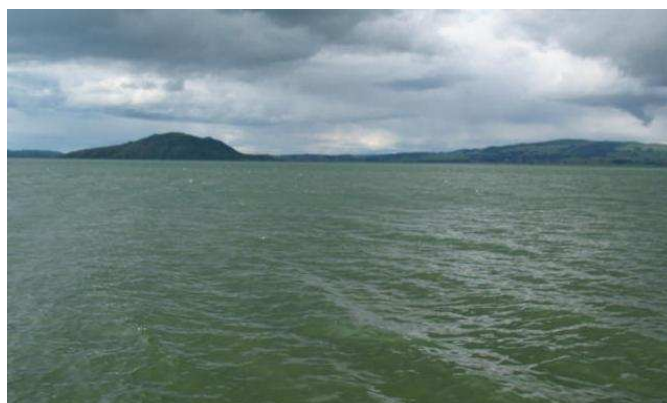
Lake condition: Moderate

Stability: Improving

Lake Rotorua is the only lake to have shown improving lake condition scores over the last 21 years. This lake has a large shallow littoral zone subject to considerable wave action, which has the effect of reducing silt build up and helps prevent large surface-reaching weed beds forming around much of the lake margin. The wave washed shallow regions of this lake can support a wide range of native turf-forming species along with shallow water charophyte beds and the presence of these native plants resulted in the higher Native Condition Index generated from the most recent 2009 survey. Charophyte meadows were recorded at 4 of the 5 LakeSPI baseline sites, compared to only 1 site in 2006, and they grew down to a maximum depth of 6.5 m. This and the extended area that the native plant communities are currently occupying has seen a 10% increase in the Native Condition Index for Lake Rotorua over the last 3 years. Care must be taken when interpreting these results however as these shallow water plant communities are also subject to seasonal storms and can be temporary in nature.

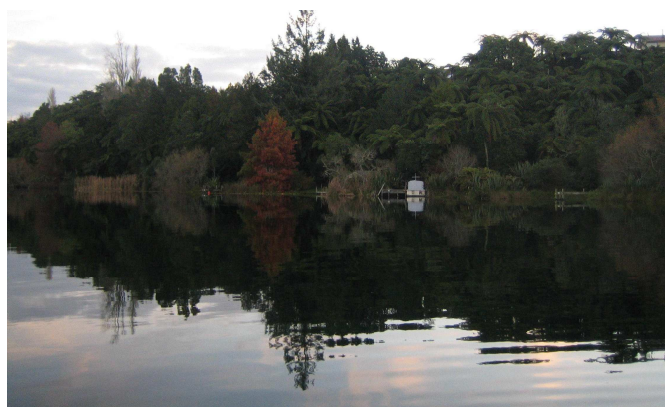
Lake condition: Poor
 Stability: Stable
 Lake ranking 10th equal

Lake Rotoiti has consistently had one of the highest Invasive Impact Index scores and during the most recent 2009 survey it continued to have one of the lowest LakeSPI Indices so far recorded for any of the 12 lakes in this region. A small increase in the LakeSPI Index over the last 3 years, 2006 to 2009, is attributable to the development of native charophyte meadows at 2 of the 5 LakeSPI baseline sites, growing to a maximum depth of 7.6 m, and is reflected by an increase in Native Condition scores.

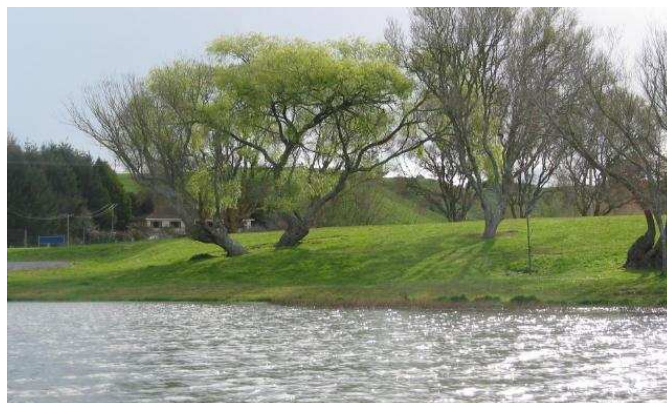
Lake condition: Poor
 Stability: Stable
 Lake ranking 10th equal

Recent efforts by Environment Bay of Plenty to reduce nutrient influx to the lake and nutrient release from hypolimnetic sediment may well improve water clarity and result in a positive vegetation response, consistent with the increase in Native Condition and Invasive Impact Indices generated from the most recent survey.

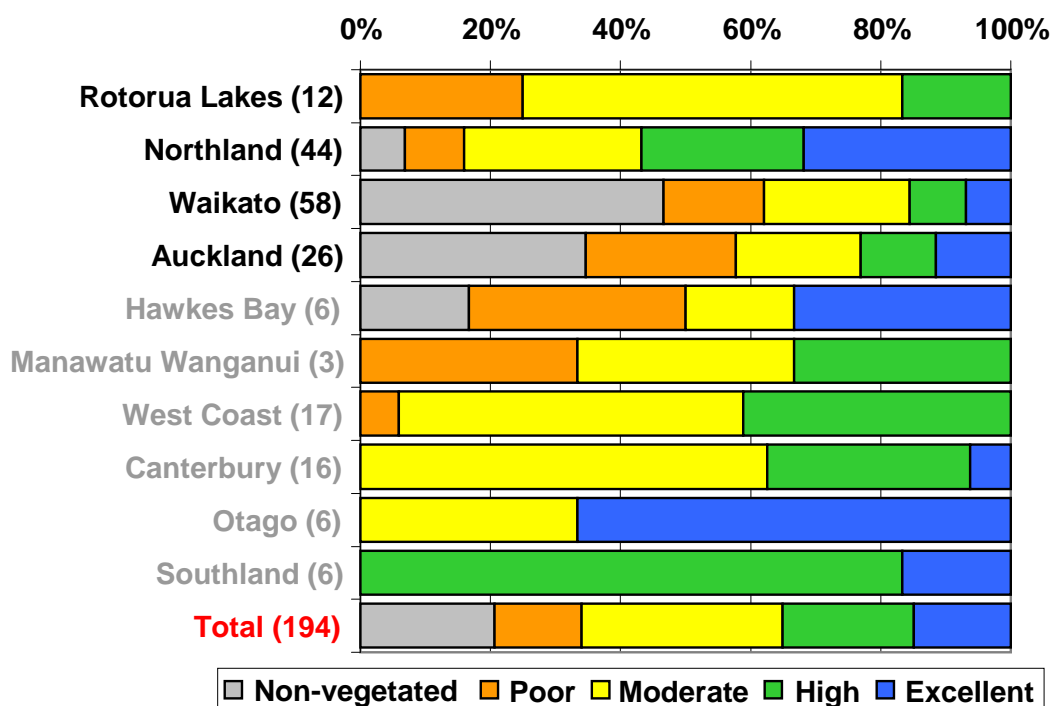
Compared nationally, the Rotorua Region have no lakes classified as being in ‘excellent’ condition (representing those close to their maximum potential ecological condition) and only two lakes classified as being in ‘high’ condition (Figure 4).

A 'moderate' condition category contains the majority of the Rotorua Lakes and contains the largest proportion of lakes nationally. This 'moderate' condition group of lakes are representative of those lakes that are impacted in varying degrees by invasive weeds.
